INITIAL SUBDIVISION OF GENESIS EARLY SCIENCE POLISHED ALUMINUM COLLECTOR. J. H. Allton¹, E. K. Stansberry², K. M. McNamara², A. Meshik³, T. H. See¹, R. Bastien¹; ¹Lockheed Martin c/o NASA/Johnson Space Center, Mail Code KT, Houston, TX 77058; judith.h.allton@jsc.nasa.gov, ²NASA/JSC, Mail Code KA, Houston, TX 77058, ³Washington University, St. Louis, MO 63130.

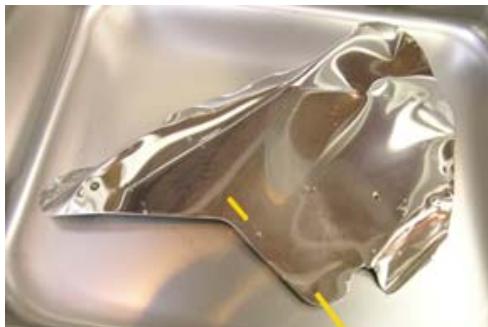
Introduction: A large surface, about 245 cm², of highly polished aluminum 6061 T6 alloy was attached to the science canister thermal panel for the purpose of collecting solar wind noble gases. The analysis of this collector will be part of the Genesis Early Science results. The pre-launch configuration of the collector is shown in Figs. 1 & 2. The collector sustained some damage during the recovery impact in Utah, September 8, 2004 (Fig. 3; for details of recovery operations see [1]).

Fig. 3. Post-impact condition of polished aluminum collector. The yellow marks correlate with those on Fig. 5.

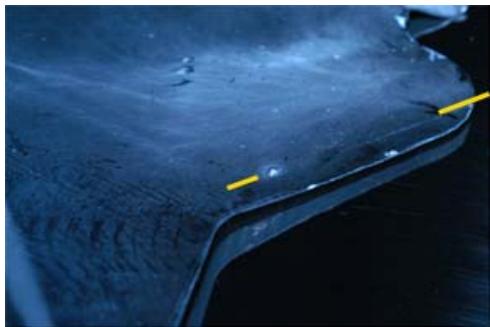
Post-flight collector surface observations. Oblique lighting revealed dust or coating patterns on the polished surface (Fig. 5). Mud spatters and smears, often ringed with evaporate deposits, were also observed. Other than nitrogen gas dust-off, no cleaning was performed. The portion of the collector to be removed and sent to Meshik was scanned to map the location of impact craters >40 μm. In this portion of the collector, comprising about 45 cm², 13 features were noted of which 8 were identified as craters ranging in size from 40 to 300 μm. Crater diameters were measured at 40, 62, 62, 62, 108, 163, 170 and 300 μm. We plan to scan the entire surface.

Fig. 5. Oblique lighting reveals dust or coatings on surface. Bright spot near center is mud/salt spatter. Between yellow lines a boundary mark exists corresponding to shadowing or impact imprint of saddle thermal shield.

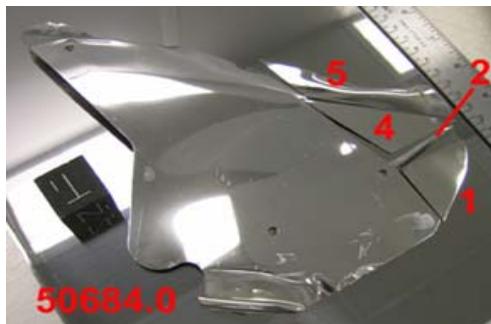
removed to separate a muddy smudge and severely curled surface from cleaner, flatter specimens. Subsample 1 and 4 are fairly flat and subsample 2 is a rib. Fig. 8 shows a close-up of quality of surface on 50684.4, including an evaporite deposit. The largest piece remains in nitrogen storage at JSC, awaiting continued scanning for micrometeorites.

Fig. 7. Group view of pieces after subdivision.
